Tech Tuesday

S38B36 & B38 Variable Resonance System | March 2020

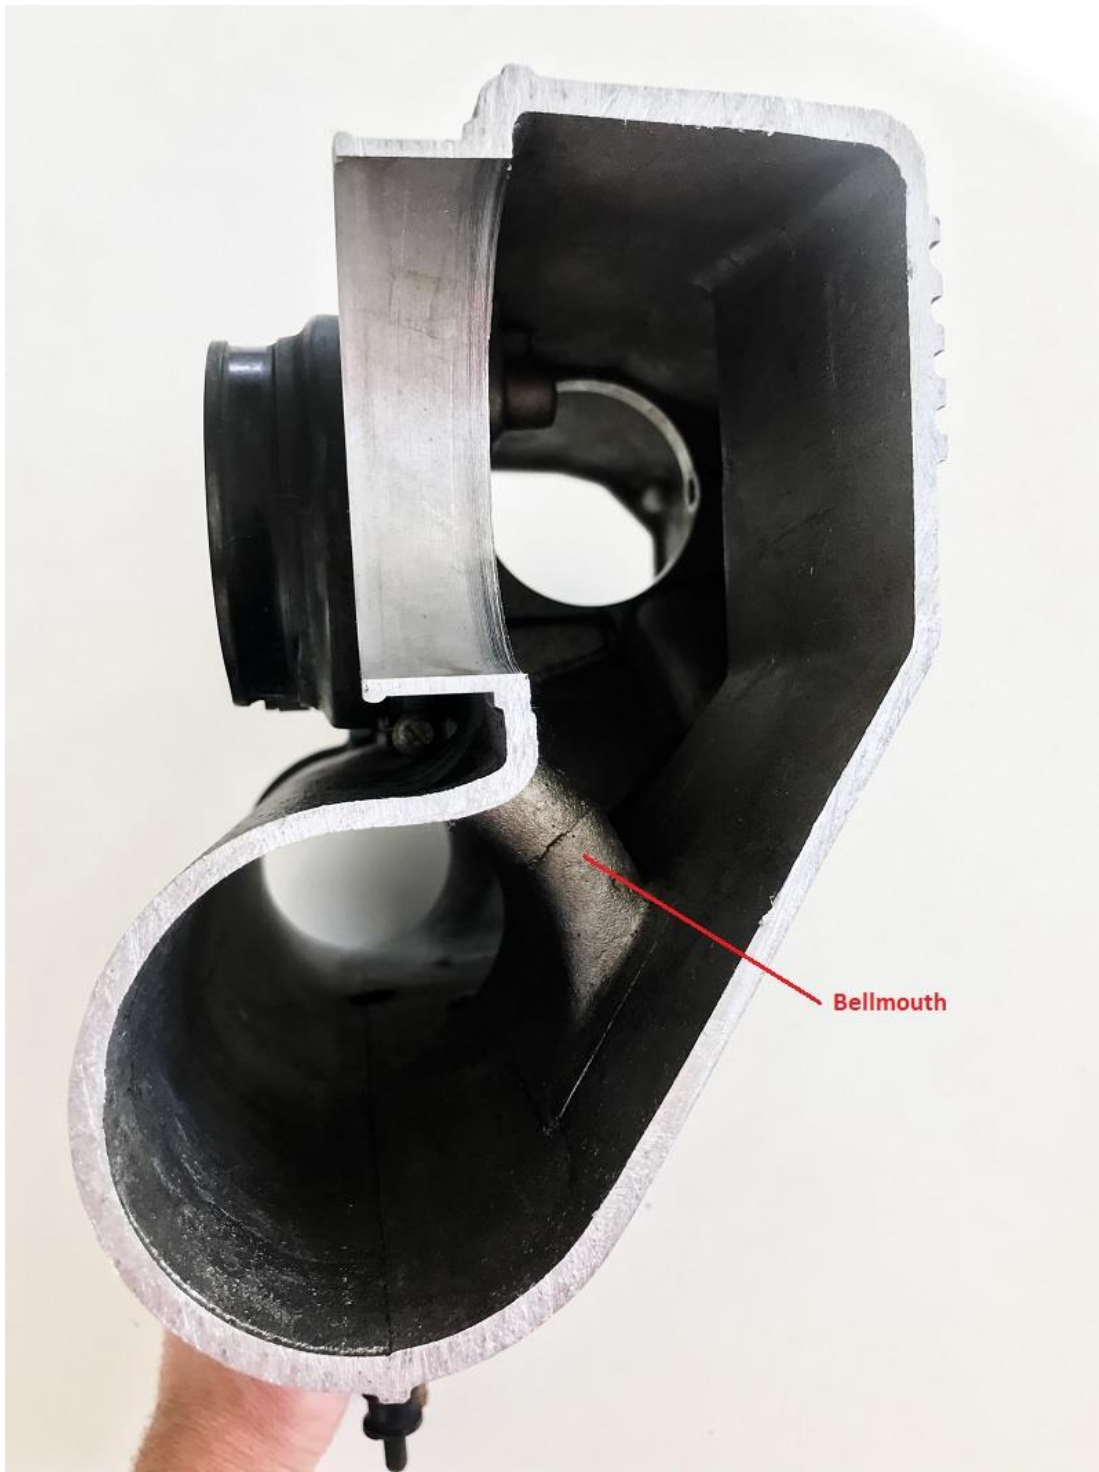
Another interesting factoid you can use to bore guests at your next dinner party is that in the lower chamber, BMW found it worthwhile to include bell-mouthed openings as is commonly seen on velocity stacks – to improve flow from the upper chamber to the lower chamber. In the course of development of our larger volume, composite intake plenum that maintains this variable resonance system, we dissected a stock plenum. This was the only way to ensure we didn't miss incorporating a single feature of this highly-developed OEM plenum, including the bell mouth feature located on either end of the lower chamber.

Figure 2 on the next page catalogs our irreversible destruction of a plenum – for science!

With this simple division of chambers, BMW gamed the pressure waves of cylinder #1 to positively influence the filling of the next firing cylinder (#5); and then #5 influenced #3, and so on. Now, back to bell mouths (in Figure 2): remember, BMW added them to the ends of the lower chamber, which seems a bit extra at first glance. But the main purpose is in fact to ensure clean flow from cylinder to cylinder to maximize the benefit of this elegant system! Basically.

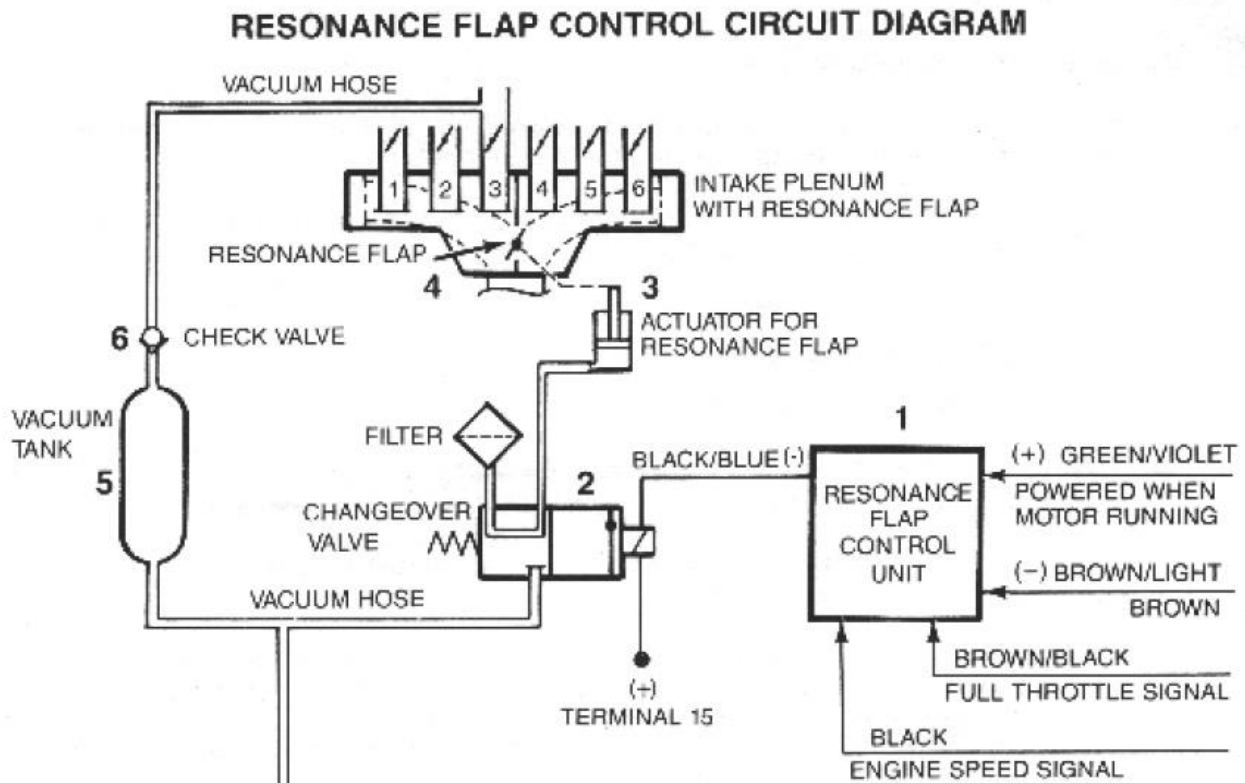
Figure 5 below is also from BMW's technical bulletin, and shows how the resonance flap is controlled and actuated on the S38B36.

The S38B36 resonance flap is electronically controlled, but vacuum actuated. The S38B38 differs from the S38B36 in that BMW added direct control of the resonance flap to the ECU. This eliminated the need for the B36's separate control unit, but besides this difference, the physical actuation of the flap is the same between the two engines.

- (1) Resonance Flap Control Unit: E-Box beneath relays.
- (2) Changeover valve (resonance flap control): mounted to underside of plenum (next to oil separator).
- (3) Actuator for resonance flap: bolted to upper side plenum.
- (4) Resonance flap: inside plenum.
- (5) Vacuum tank: beneath #5 intake runner.

As shown in Figure 5, the system is actuated by vacuum, so if your engine has any vacuum leaks, the resonance flap will fail to function. We highly suggest our S38 Intake System Vacuum Maintenance Kits, assembled for this very purpose and taking the guesswork out of parts diagram searching. Our kit offers options for upgraded components that are more durable than the BMW parts, extending the life of this valuable system.

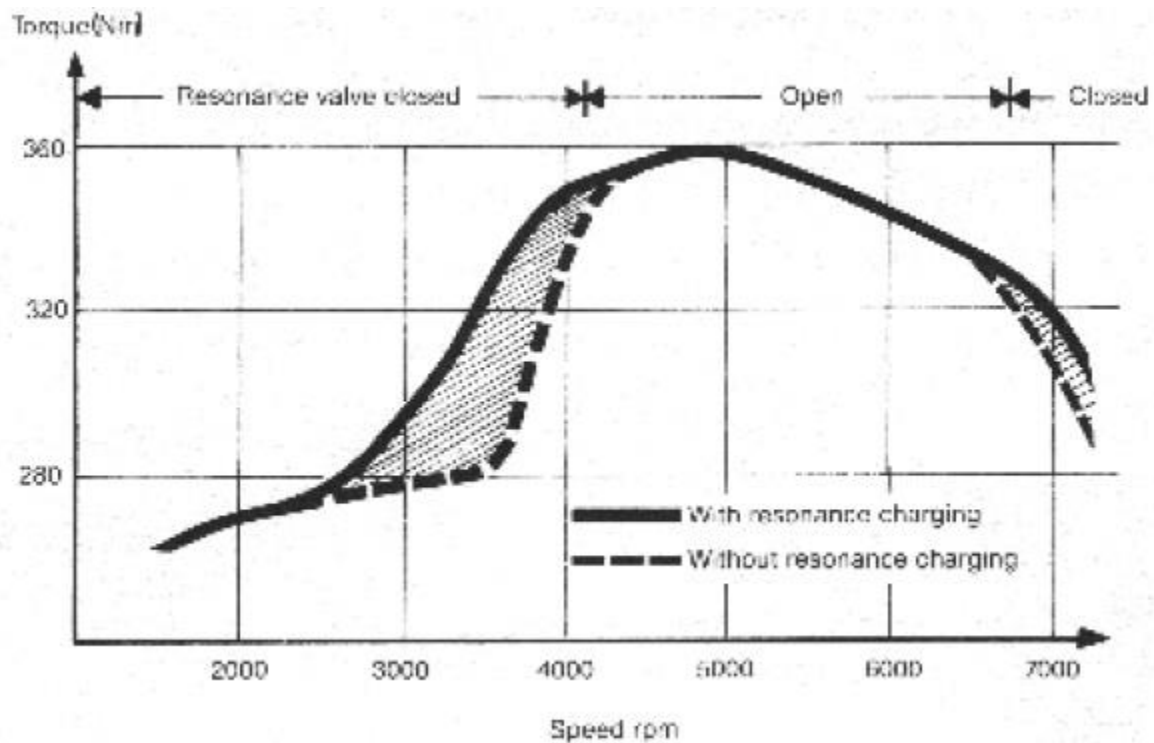
Detailing the added benefit of this system, in Figure 7 BMW handily graphed the difference between a functional variable resonance system (resonance “charging”), and going without the system entirely.
